PROPERTY & LIABILITY INSPECTION

March 2010

WEST HILLS COMMUNITY COLLEGE

KEENAN & ASSOCIATES

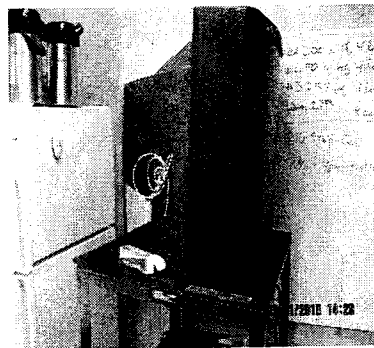
BLDG A

The television located on the portable cart was not secured. The television should be secured to prevent tip over accidents.

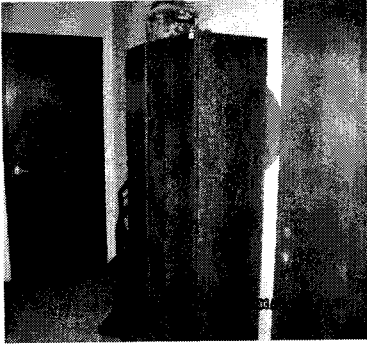
BLDG A

The storage cabinet in Building A of the Coalinga Campus should be anchored to prevent

tip over or inadvertent movement.

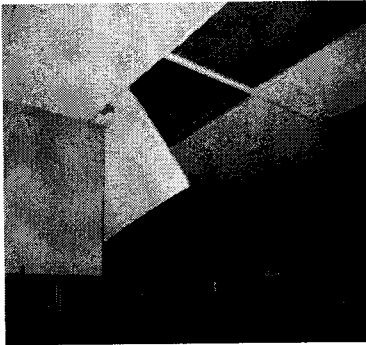
**COALINGA CAMPUS
MENS LOCKER ROOMS**

The unsecured ceiling tile in mens locker room should be anchored or removed.

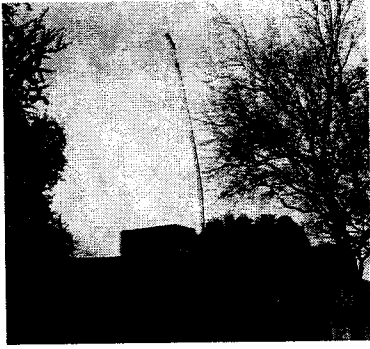
**COALINGA CAMPUS
VERNON JORDAN HALL - MENS DORM**

The antenna on top of the Mens Dorm should be removed from roof top area to prevent device from falling and injuring staff or student.

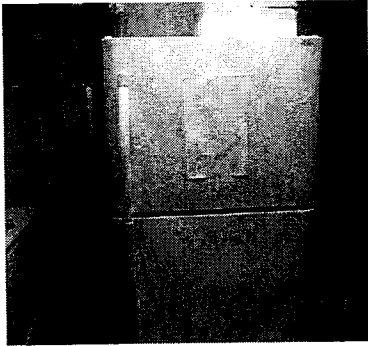
RM 12

The refrigerator should be clearly labeled for the type of storage and the rule strictly enforced.

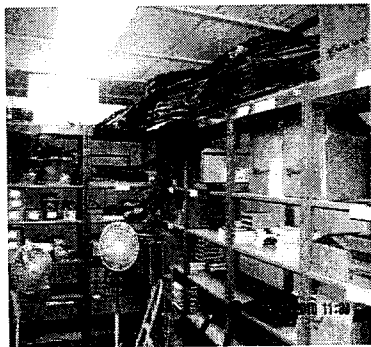
RM 508

The material (cardboard) create a fire hazard and should be removed. (See Photo)
